Loss Control Inspection

**MUNICIPAL INSURANCE ASSOCIATION
OF BRITISH COLUMBIA**

Area: Barriere, District of

Date Range: 06-Sep-2022 to 06-Oct-2022

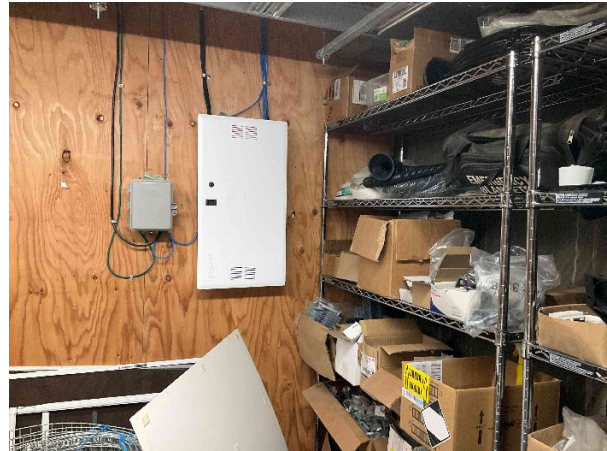
It was noticed that there are several boxes and paper products. It is recommended that the District review the

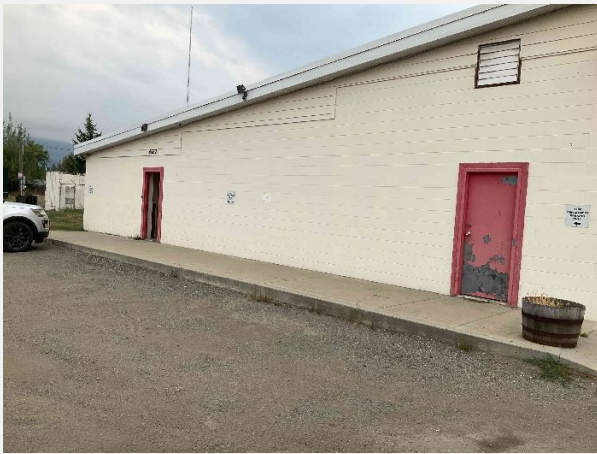
The door is weathered and the paint is flaking off leaving the door exposed to the elements and open to more deterioration. It is recommended that the District review the doors and remediate, as necessary.

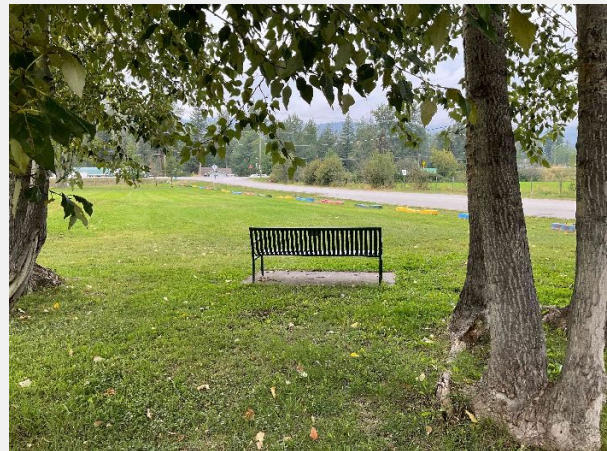
There park does not have any fencing. It is however, delineated by brightly coloured no-post barriers to restrict vehicle access. It is recommended that the District consider fencing to close off any gaps between the no post barriers and prevent children from running out into the street.

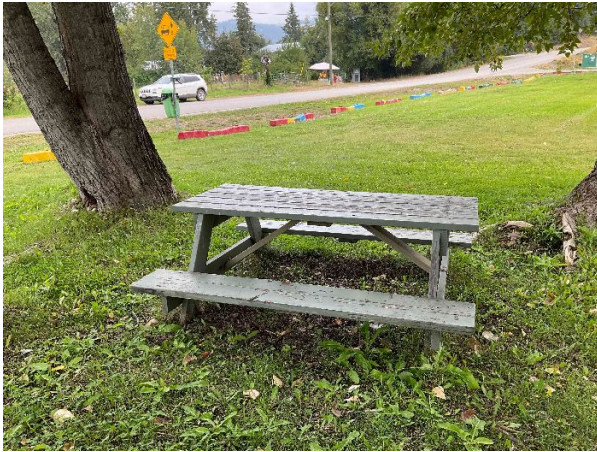
Are the Garbage Cans in good condition?	Yes	
Are the Benches in good condition?	Yes	
Are the Bleachers in good condition?	NA	
Are the Picnic Tables in good condition?	No	
Picnic tables are showing signs of wear and tear. It is recommended that the picnic table be reviewed to monitor or remediate, as necessary, to prevent an injury.		
Has the fault been repaired? No	Priority: Low

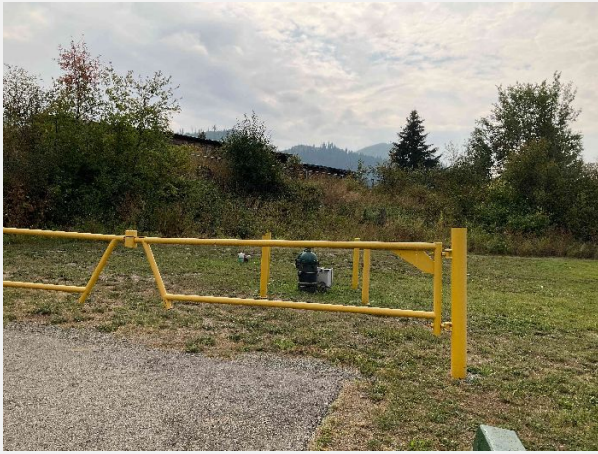
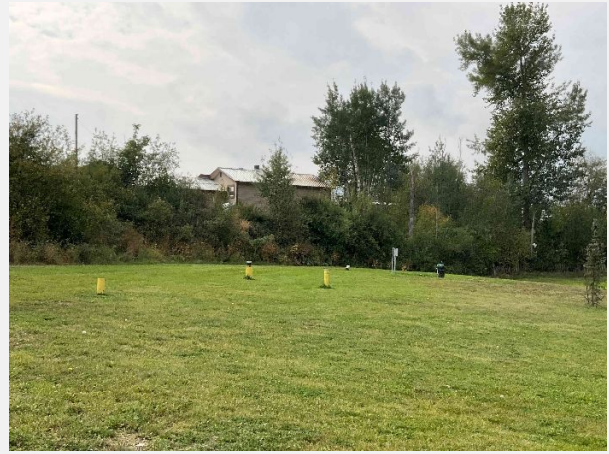
Wells are in the park's passive green space and are fully exposed. Impact can cause property damage or bodily injury. It is recommended that the District implement a shield such as bollards or no-post barriers to prevent an accident from occurring.

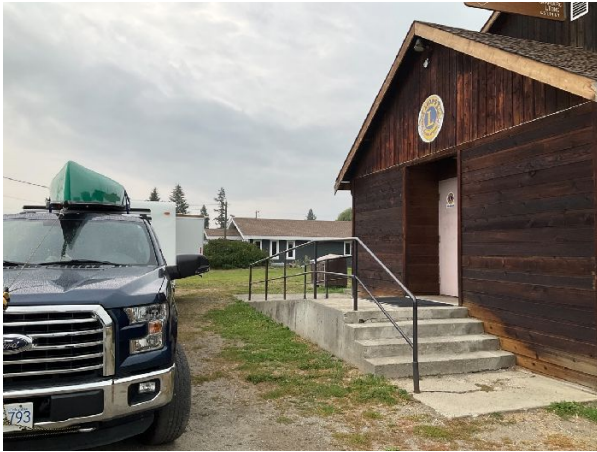
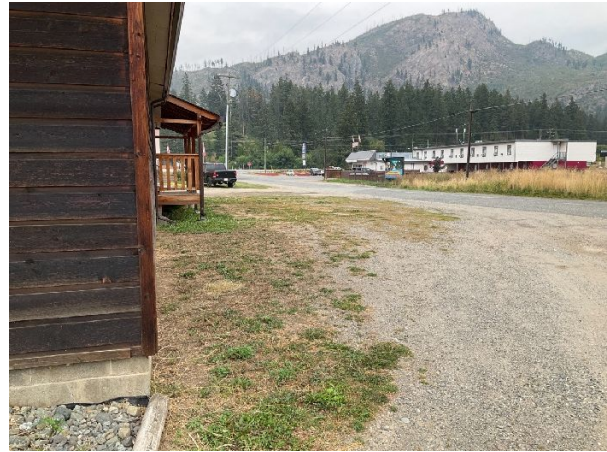
There are no curb stops in place. See recommendation above.		
Has the fault been repaired? No	Priority: Low

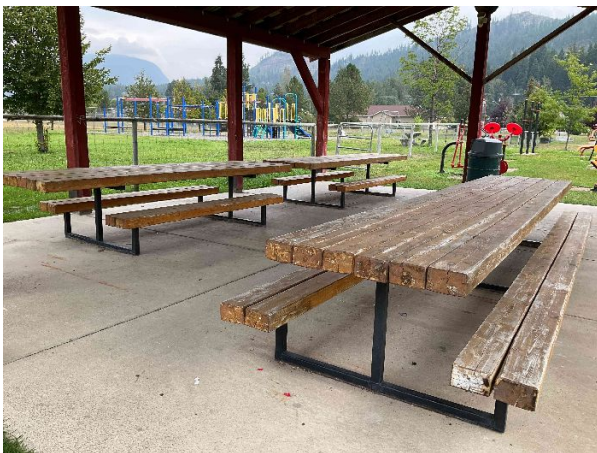
The picnic tables are showing signs of wear and tear. It is recommended that the District review the picnic tables and remediate, as necessary, by sanding and/or repainting.

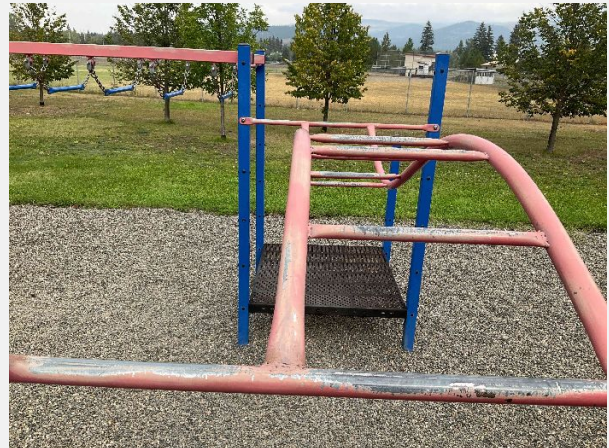
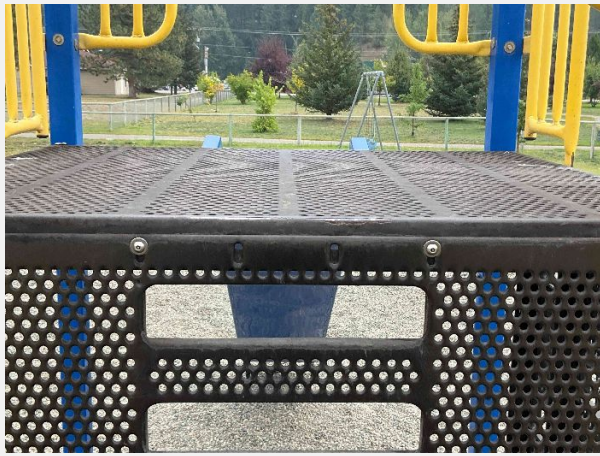
The playground is showing signs of wear and tear. It is recommended that the District monitor the area and remediate, as necessary to prevent an injury.

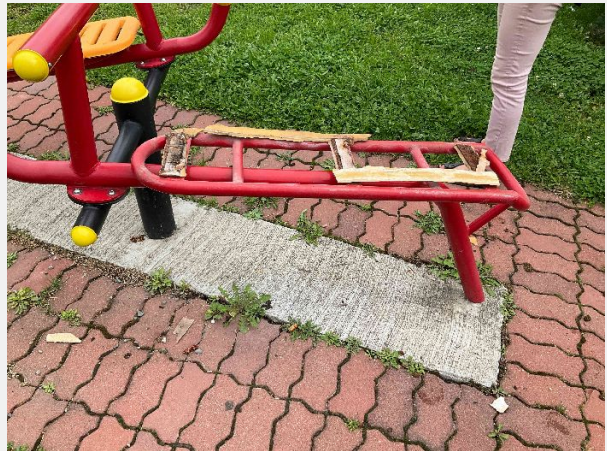
Several of the outdoor fitness equipment is showing signs of damage. It is recommended that the equipment be inspected and repaired or replaced as needed to reduce the possibility of bodily injury of users. It was also noticed that some of the handles on this equipment are exposed and at a height that might cause bodily injury, it is recommended that the District consider capping these handle ends with a softer material (ex. rubber) to prevent an accident, as necessary.
