# Bulk Water Feasibility Study

District of Barriere

February 2022

Project No. 346-441

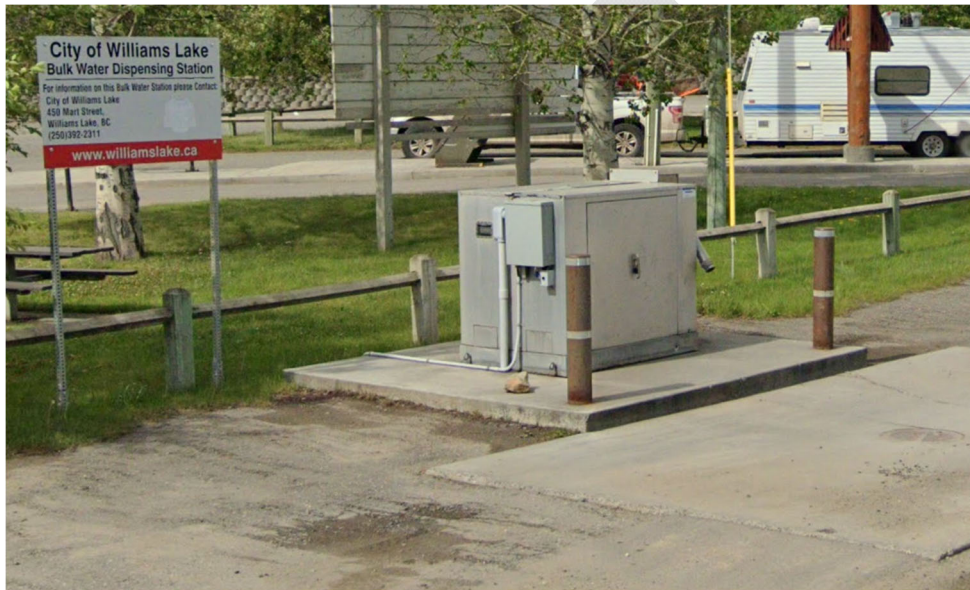
**FIGURE 4-1: WILLIAMS LAKE WATER DISPENSER, STAMPEDE GROUNDS**

The City of Williams Lake installed a pre-packaged dispenser (Birksco TFS-3-A-M3 Single Outlet Commercial Bulk Water Station) next to the sani-station at the Stampede grounds in 2012. Users pre-purchase credit for bulk water on a reusable card. They can go to the bulk water station at any time and swipe the card to access water.

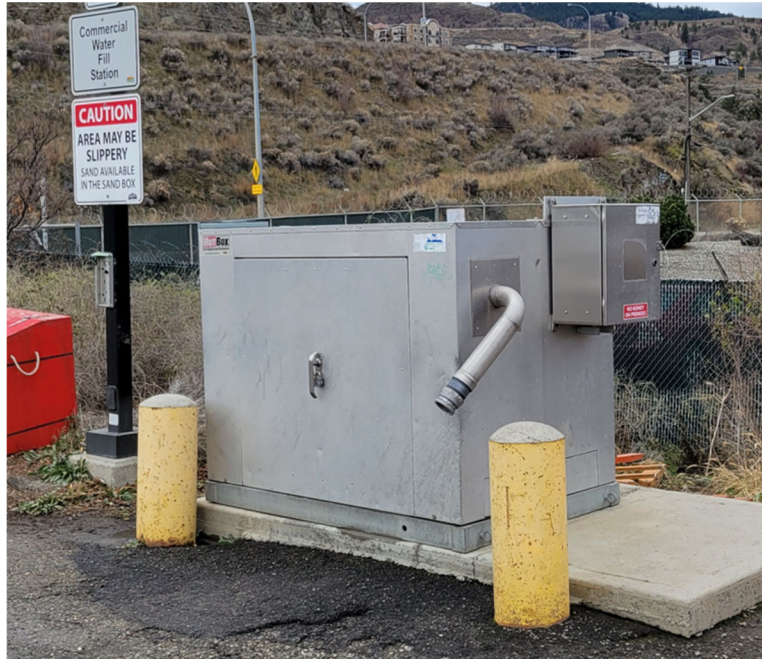
**FIGURE 4-2: CITY OF KAMLOOPS WATER DISPENSER, MISSION FLATS ROAD**

The City of Kamloops has the same make and model dispenser installed at the Mission Flats sani-station and at the recycling depot on Bunker Road.

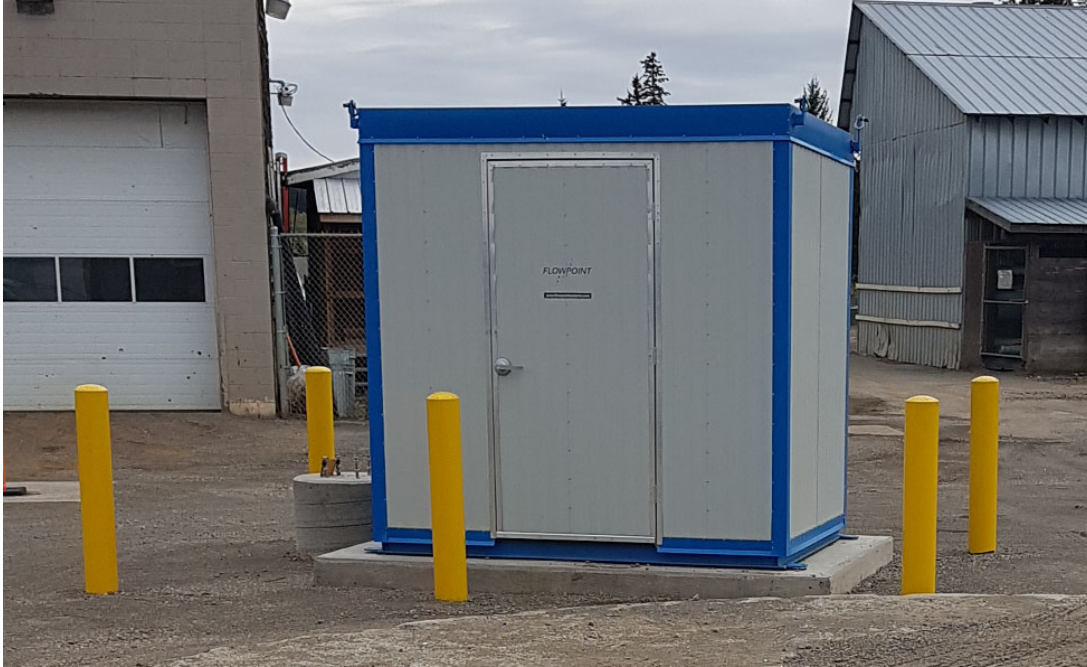
**FIGURE 4-4: DISTRICT OF 100 MILE HOUSE BULK WATER DISPENSER, HORSE LAKE ROAD**

A Flowpoint Environmental Systems bulk water dispenser system was installed in 100 Mile House for year round use in 2017.

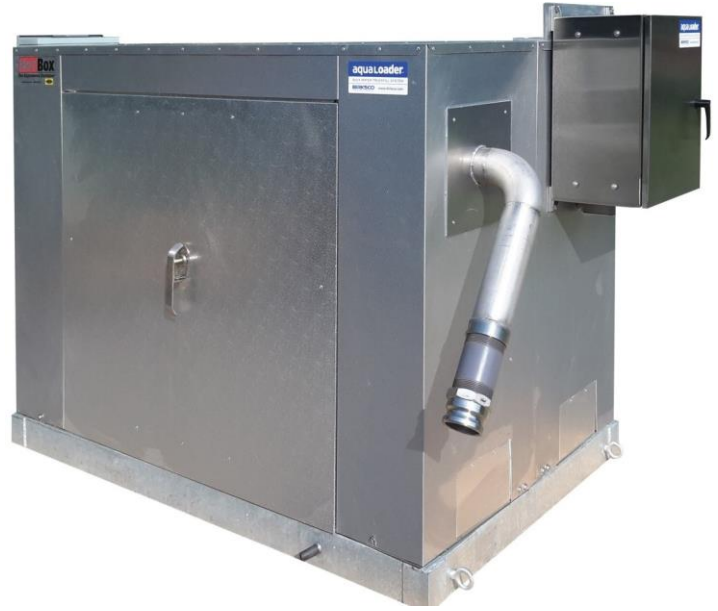
External Dimensions (w/Skid, Less Electrical Panels)  
1650 mm L x 1070 mm W x 1360 mm H  
(65" x 42" x 51.5")

- ◆ Pre-Paid or Billing w/Credit Limit Control System
- ◆ Keypad Only access w/PIN Number, or
- ◆ Touch Memory Fob w/PIN Number
- ◆ Stainless Steel (NEMA 4X) Terminal Cabinet
- ◆ Rated for External temperatures of -34°C (-30°F)
- ◆ Dual Heater Option Supplied as Standard
- ◆ Service size 100mm (4")
- ◆ Outlet size - One (1) x 75mm (3") connection
- ◆ Outlet Rated for up to 1100 L/m (300 usgpm)
- ◆ Other sizes are available
- ◆ Inlet Water Pressures up to 1200 kPa (175 psi)
- ◆ Integral Adjustable Flow and Pressure Control Valves
- ◆ Power Supply requirements - 120vac/60a/1 Phase
