Loss Control Inspection

**MUNICIPAL INSURANCE ASSOCIATION
OF BRITISH COLUMBIA**

Area: Barriere, District of

Date Range: 06-Sep-2022 to 06-Oct-2022

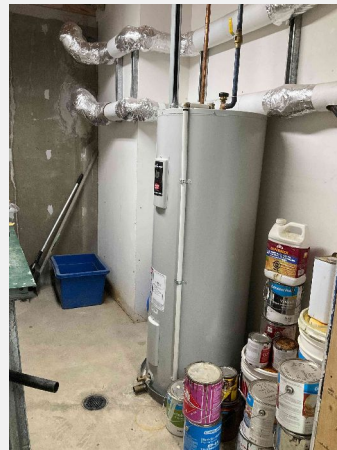
It was noticed that there are some paint cans and a work bench with supplies. It is recommended that the District review the area and remove the items to provide the adequate clearance, as necessary.

Priority: Medium

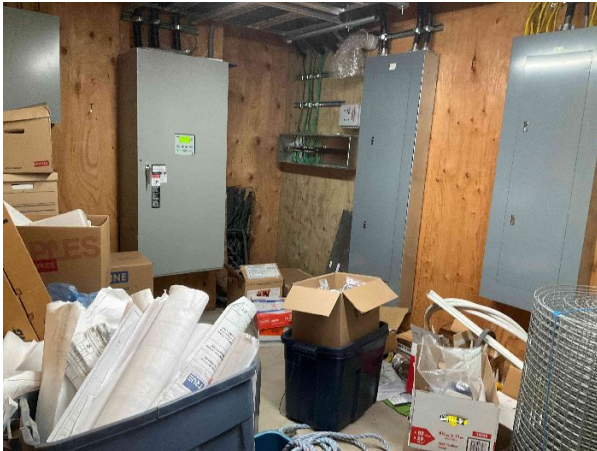
Are the electrical rooms free of storage? (at least 1m from equipment)	No	⚠
--	----	---

It was noticed that there are several boxes and paper products. It is recommended that the District review the

Priority: Medium

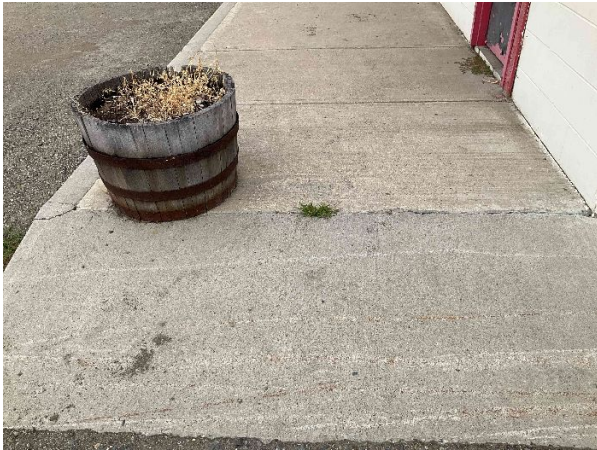
Are the parking lot's sidewalks/ walkways in a good condition?

There are a few cracks forming on the walkway around the perimeter of the building. It is recommended that the District review the area to monitor, mark, repair, or replace, as necessary, to prevent a trip and fall

Priority: Low

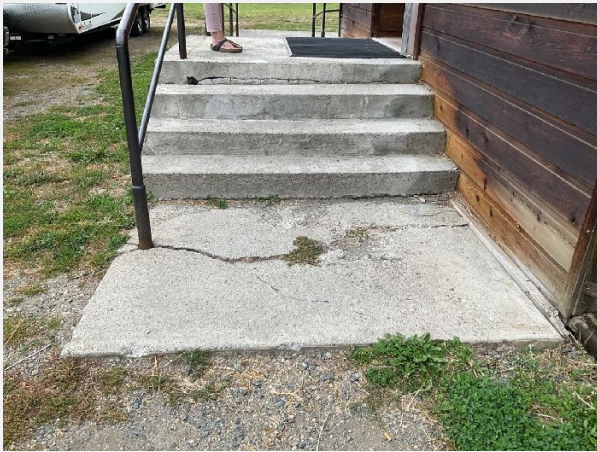
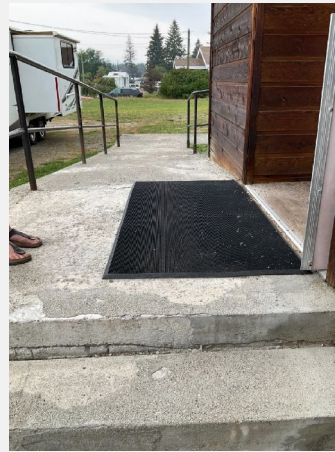
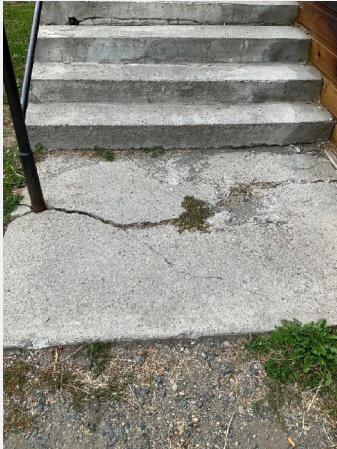
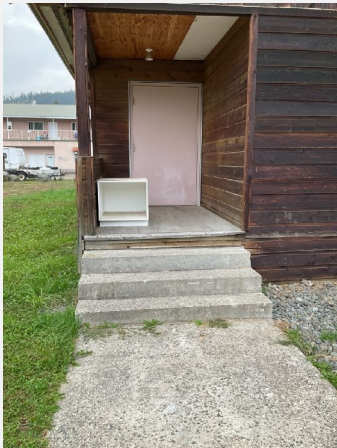
Signs of damage and deterioration noted including, cracking, spalling, scuffing and others. It is recommended that the District review the area to mark, repair or replace, as necessary in order to prevent bodily injury to users.

Priority: Medium

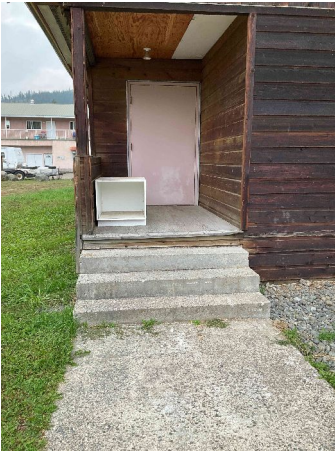
Interior exits were free of obstructions, however, on the exterior, there has been something stored at the doorway which could impede safe evacuation of the premises. It is recommended that the District review the area and remove items blocking the doorways.

Priority: Medium

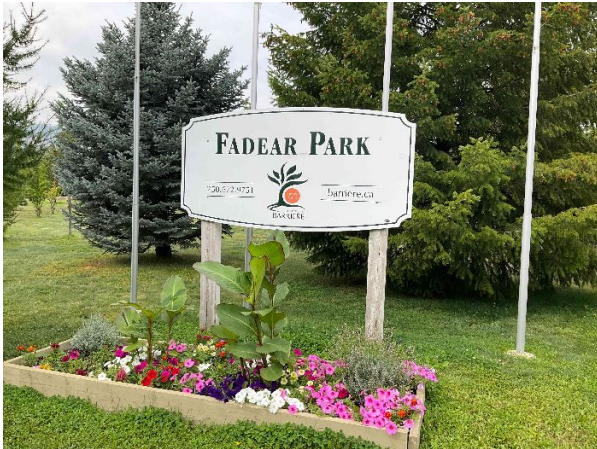
Park signage has important information missing. It is recommended that the District consider implementing a general sign at the main entrance with contents including:

safely use the space. (Ex. supervision required, no foul language, no use of alcohol or other substances, recommended age requirements for play structure use, etc.)

Priority: Low

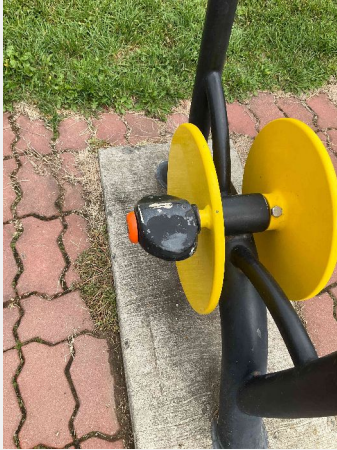
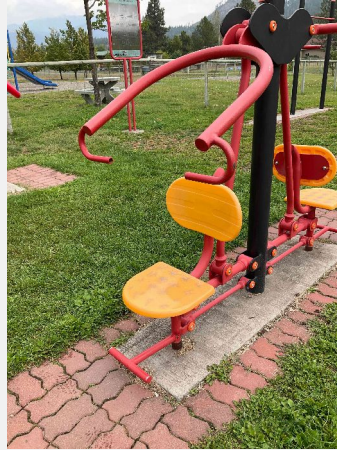
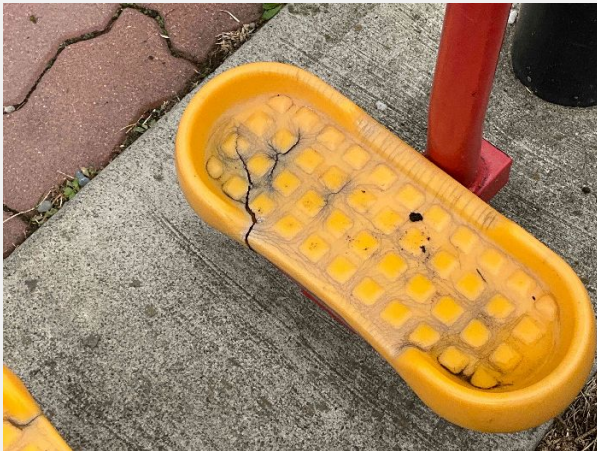
Priority: Medium

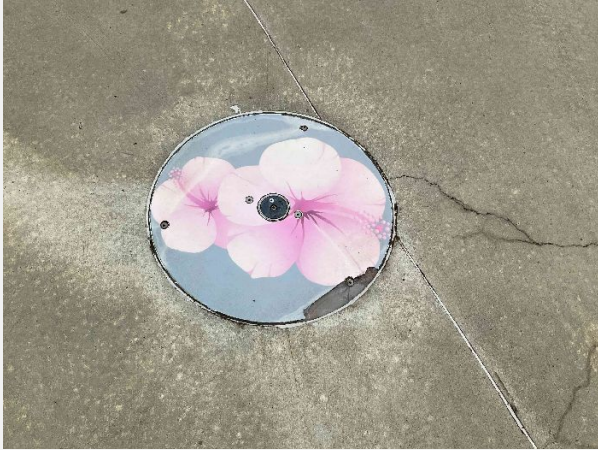
Priority: Low

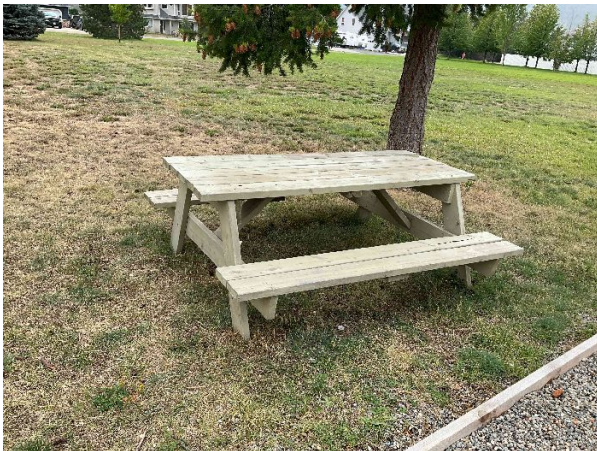
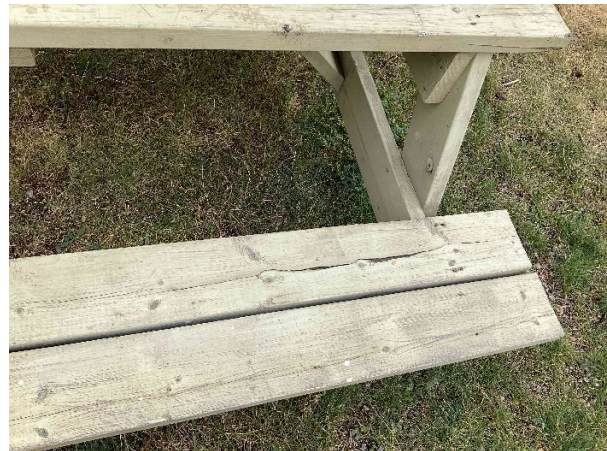
Priority: Low

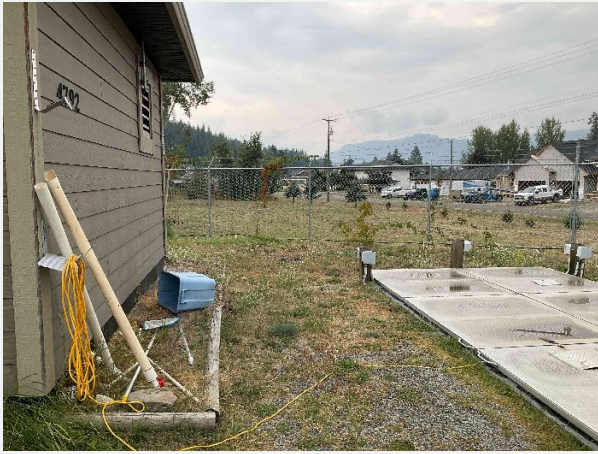
Supplies have been left on the grounds unattended. It is recommended that the District review the area to safeguard supplies that are not in use so that unauthorized personnel do not have access and prevent bodily injury or property damage.

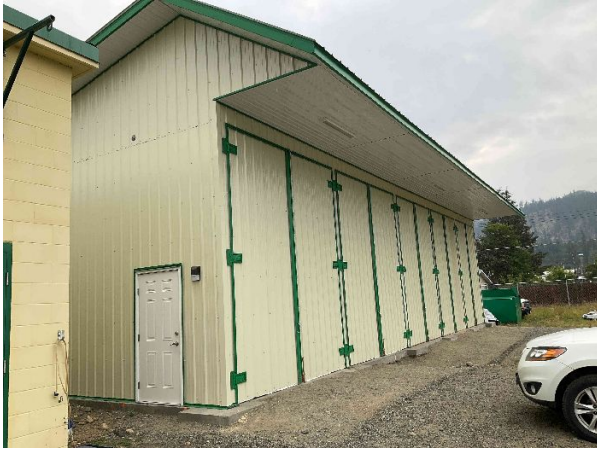
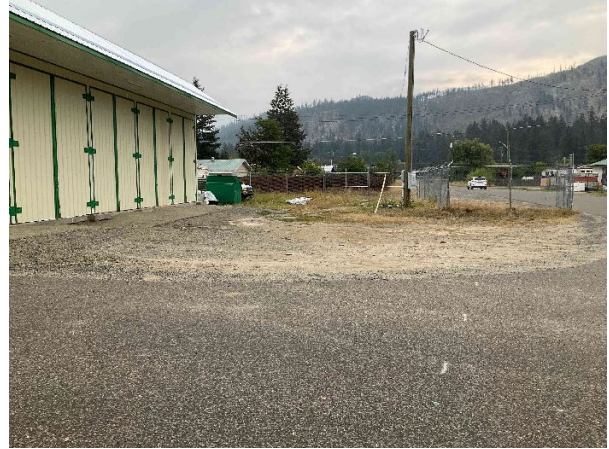
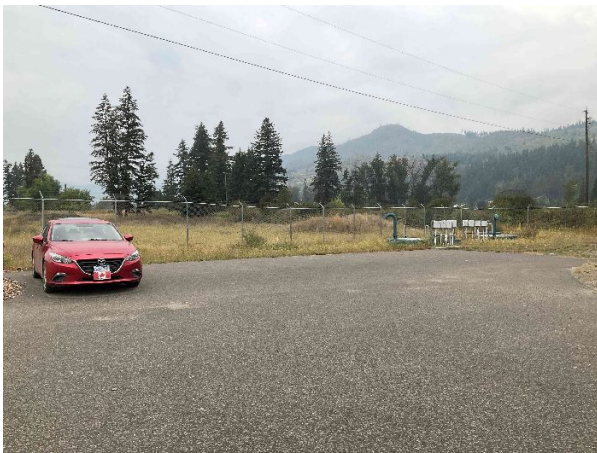
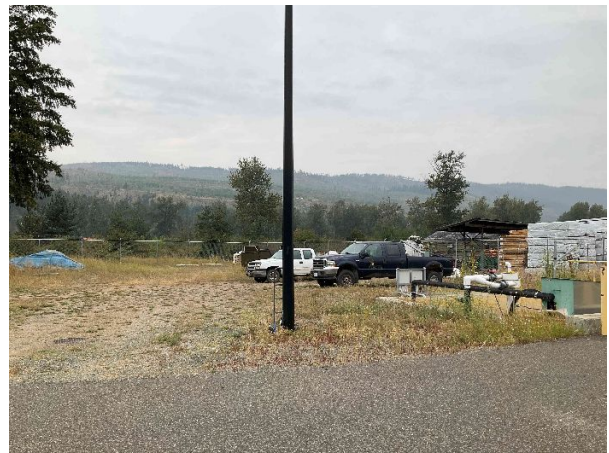
There are no curb stops in front of the the building and the parking area is not delineated nor is there signage that designates the parking area. It is recommended that the District review the area to designate and delineate the parking area. If the expectation is that no vehicles should be parking directly around the building as there is adequate space in the parking area, then there should be signage communicating that there is no parking allowed in front of the building.

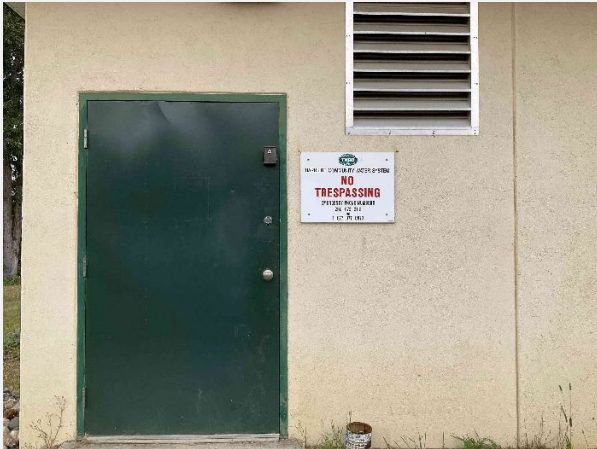
Has the fault been repaired? No

Priority: Low

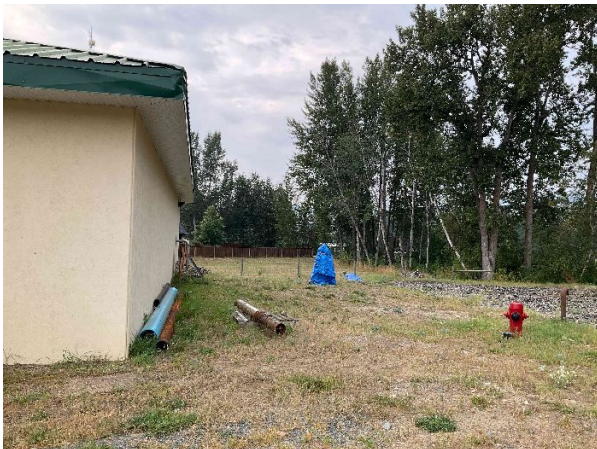
Has the fault been repaired? No

Priority: Low

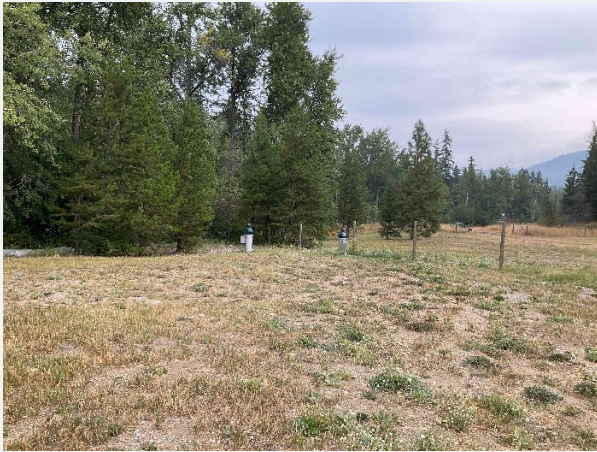
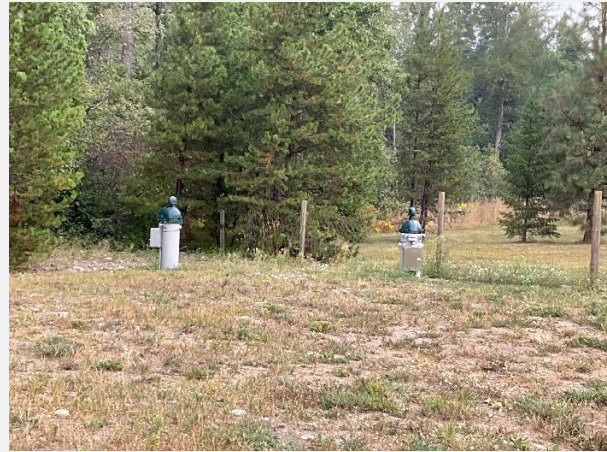
Has the fault been repaired? No

Priority: Low
